Camp Lick Project

Watershed Report

Prepared by:
Bob Hassmiller
District Hydrologist

for:
Blue Mountain Ranger District
Malheur National Forest

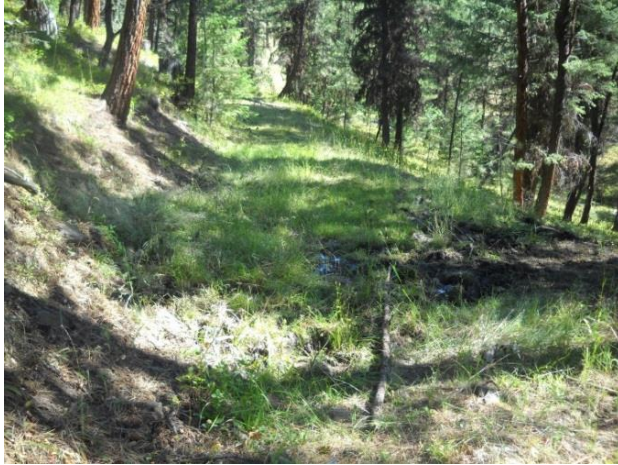
Figure 2. Spring in NFS Road 3600941

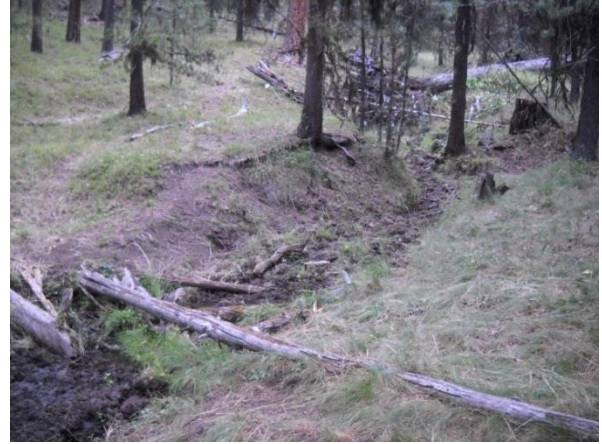
Figure 4. Stream crossing with culvert removed on NFS Road 3600208

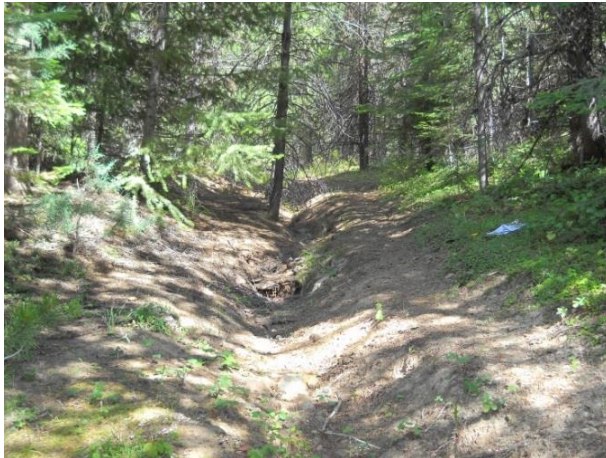
Figure 3. Stream channel/gully in center of road surface on NFS Road 3640243

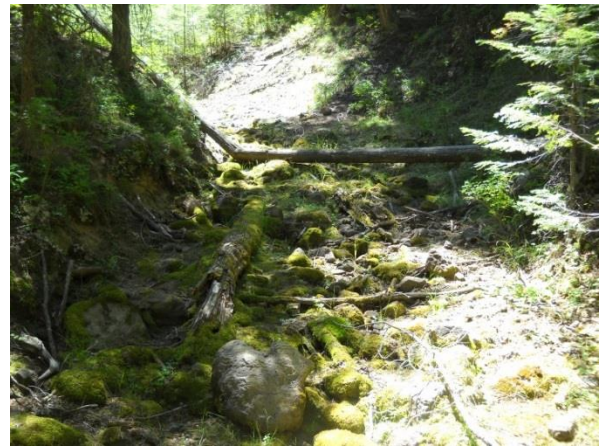
Figure 5. Stream captured by road and is now stream channel on NFS Road 3650631

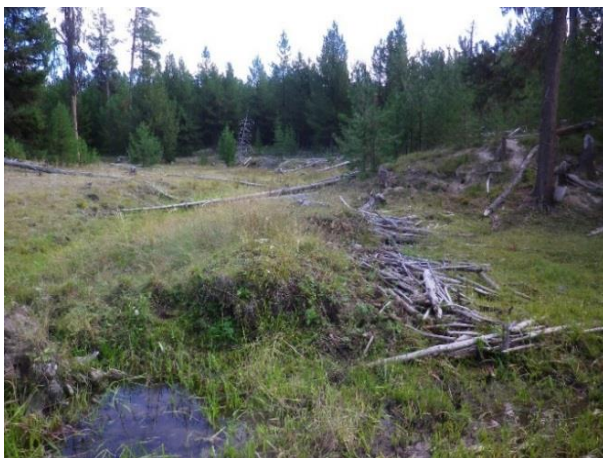
pine that is encroaching towards the channel due to drying trends

Figure 7. Camp Creek reach 11 illustrating a beaver dam that is not functional and lodgepole

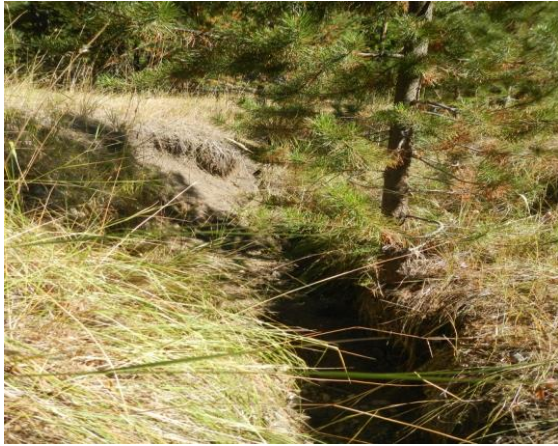
Figure 8. Gully present within a stream channel on Coxie Meadow and lodgepole pine that has established within the meadow adjacent to the gullies

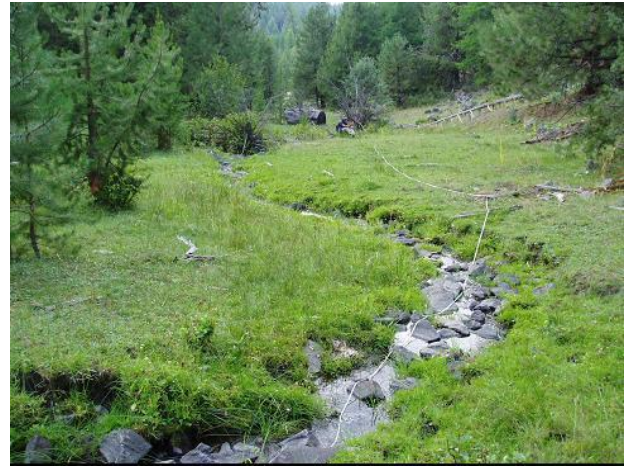
Figure 9. Camp Creek reach 10 illustrating large streambed substrate

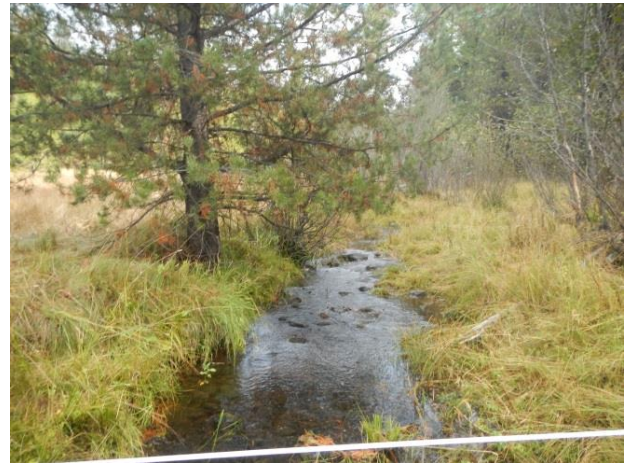
Figure 10. Cross section survey at Camp Creek river mile 12.2 illustrating channel incision and lodgepole pine encroachment

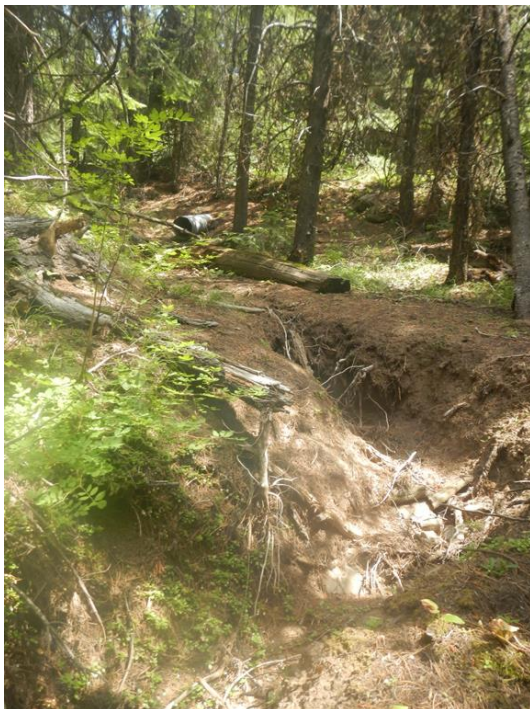
Figure 13. Eroding Camp Creek headwater tributary

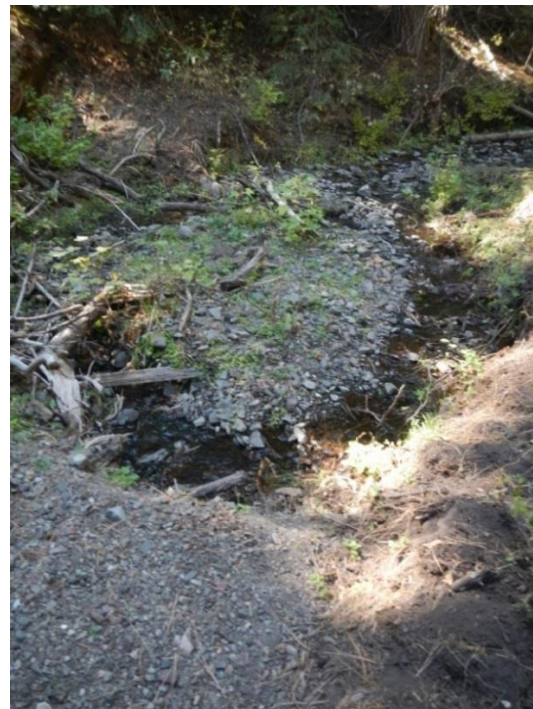
Figure 14. Sulphur Creek showing low instream wood volumes (large wood jam features once stored sediment and water later into the summer)

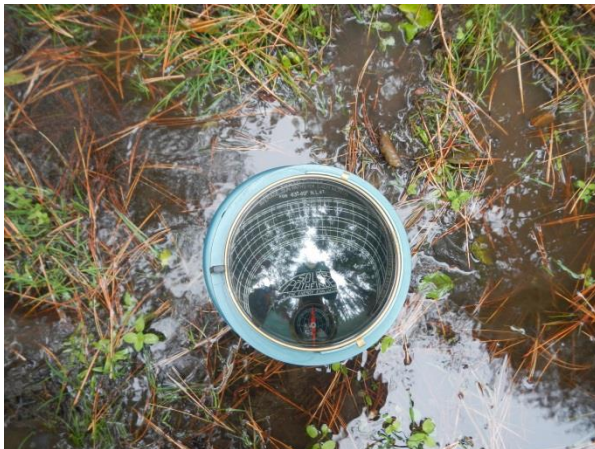
Figure 16. Solar pathfinder measuring the amount of effective shade provided by adjacent vegetation and hillslopes

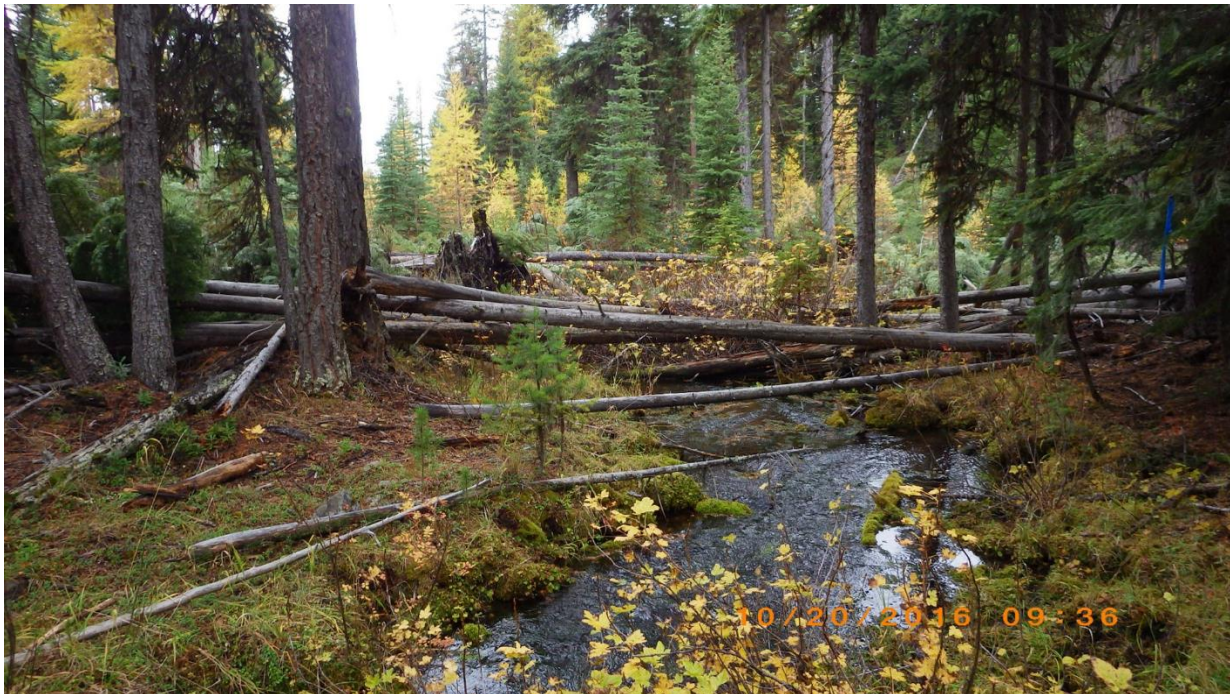
Figure 18. Windthrow and flood disturbances resulting in a canopy opening with early seral tree species, abundant down wood, and riparian hardwoods present

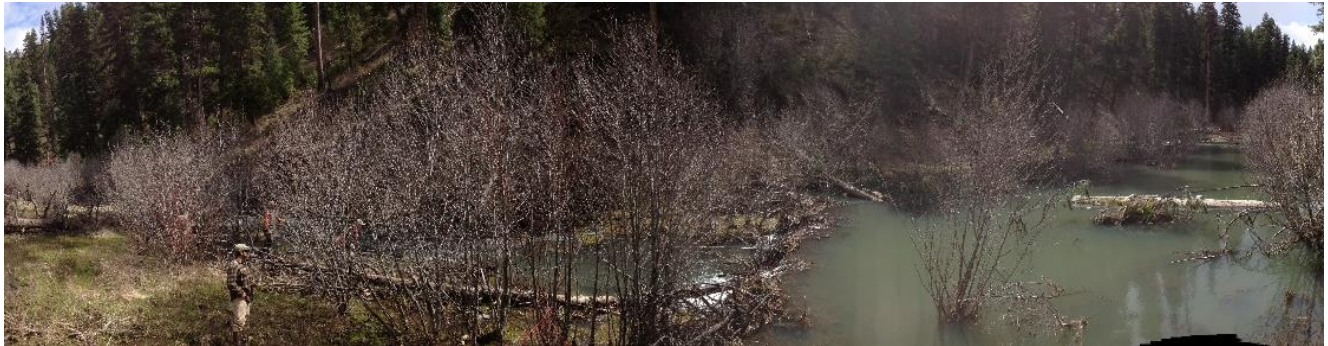
Figure 19. A 4-foot persistent beaver dam anchored off a large woody debris jam in Camp Creek reach 4 illustrating the benefits of floodplain connectivity, groundwater recharge, and water attenuation

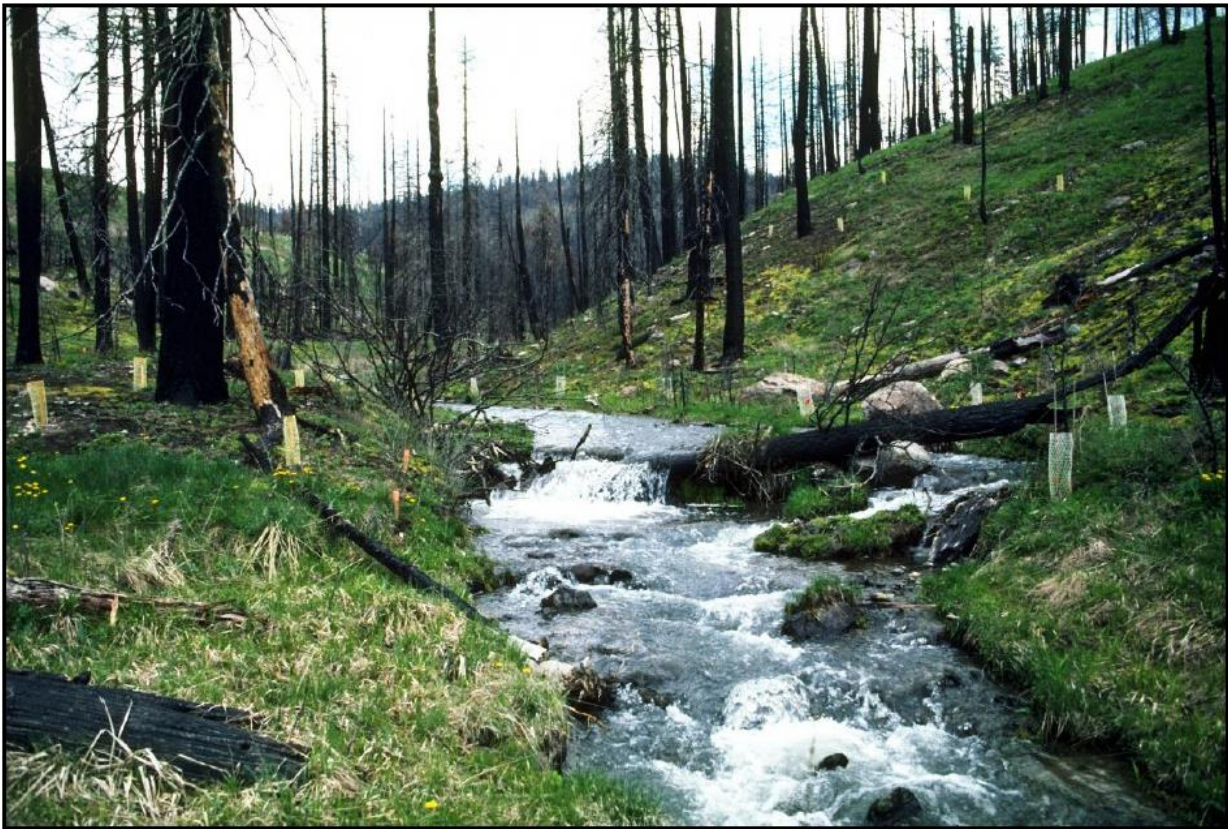
Figure 20. Photograph of Texas Bar Creek in the Tower wildfire area showing a lack of natural riparian hardwood recruitment

The Tower wildfire on the Umatilla National Forest could be an example of the no action alternative. They observed the need to plant riparian hardwoods to establish shade following the wildfire, likely because the riparian hardwoods were not in a resilient condition to respond to the wildfire impacts and resprout quickly (see Figure 20). This lapse in stream shade in the Camp Lick planning area could negatively impact water temperatures from providing beneficial uses to aquatic species.
